**Flood Control Project Maintenance  
Levee Inspections**

**Fall 2019 Levee Maintenance Deficiency Summary Report**

**Flood Control Project Maintenance  
Levee Inspections****LMA District Cover Sheet****Fall 2019 Levee Inspection Results****Sutter Maintenance Yard East-West Interceptor**

**Sutter Maintenance Yard East-West Interceptor**

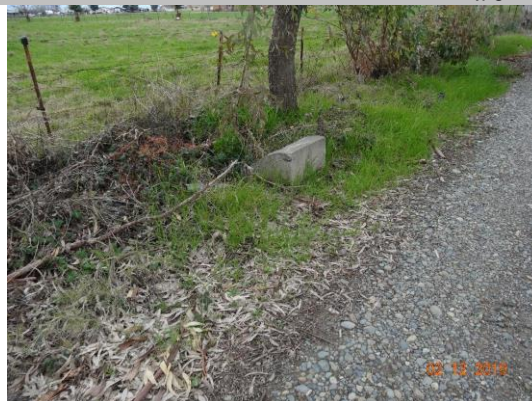
Photo 3 of 3 : UCIP\_FA\_2019\_55482\_78999.jpg

LS view: concrete headwall located on LS shoulder.

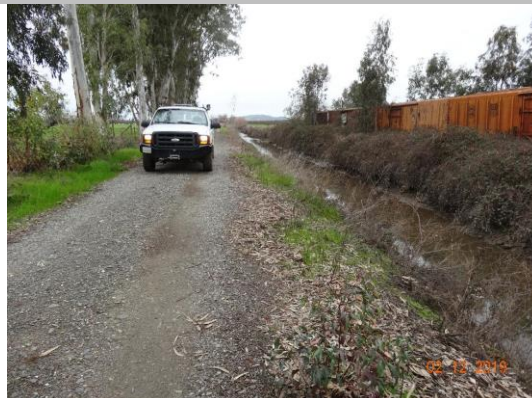
Photo 1 of 3 : UCIP\_FA\_2019\_55483\_79002.jpg

Comment Code						
Inspector Comment						
DS_ID:20122						
FS_ID:55483						
EP_NO: N/A						
Repair Type: Non-Urgent						
Crossing Status: Not Found						
UCIP Comments: 02/12/2019 Unit 2 known as the East Levee (East Interceptor Canal) is considered a high ground levee with no defined levee prism, any issue found along this Unit will be considered a maintenance issue, an unauthorized encroachment, or an abandoned encroachment. Record remains Non-Urgent, no permit has been found authorizing pipe crossing. (O. Magana - DWR UCIP)04/10/2017 Crossing appears to be in good condition. (DWR Sutter Yard-AFreitag)10/11/2016 Crossing appears to be in good condition.(DWR Sutter Yard - afreitag)04/19/2016 Crossing appears to be in good condition.05/12/2015 Crossing appears in good condition. No noticeable issues to report.11/17/2014 Same as last inspection.05/12/2014 Same as last inspection.11/04/2013 Same as last inspection.05/15/2013 Same as last inspection.10/16/2012 No permit identified for crossing.

Overview of levee section (high ground) where pipe should cross.

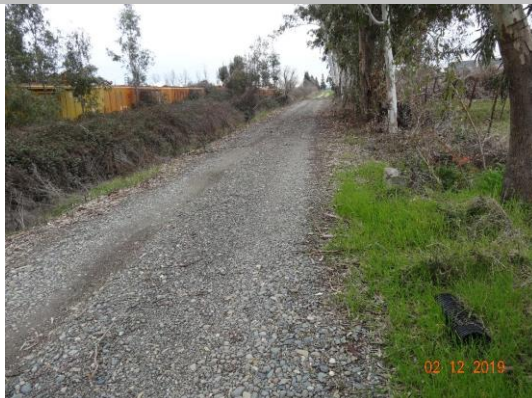
Photo 1 of 3 : UCIP\_FA\_2019\_55484\_79005.jpg

Comment Code						
Inspector Comment						
DS_ID:20120 FS_ID:55484 EP_NO: N/A Repair Type: Non-Urgent Crossing Status: Found UCIP Comments: 02/12/2019 Unit 2 known as the East Levee (East Interceptor Canal) is considered a high ground levee with no defined levee prism, any issue found along this Unit will be considered a maintenance issue, an unauthorized encroachment, or an abandoned encroachment. Record remains Non-Urgent, no permit has been found authorizing pipe. (O. Magana - DWR UCIP)04/10/2017 Crossing appears to be in good condition. (DWR Sutter Yard- AFreitag)10/11/2016 Crossing appears to be in good condition. (DWR Sutter Yard - afreitag)04/19/2016 Crossing appears to be in good condition.05/12/2015 Crossing appears in good condition. No noticeable issues to report.11/17/2014 Same as last inspection.05/12/2014 Same as last inspection.11/04/2013 Same as last inspection.05/15/2013 Same as last inspection.10/16/2012 No permit identified for crossing. FIELD_STRUCT_DESC: 5-inch aluminum drainage pipe through the levee (high ground levee), 1 foot below the crown. Flap gate located on the waterside (WS) with concrete headwall block on the landside (LS). No permit has been identified since crossing was field discovered in 2012. FS Date: 2/12/2019 12:25:00 PM

Overview of levee section (high ground) looking east towards crossings, 5- and 7-inch pipes.

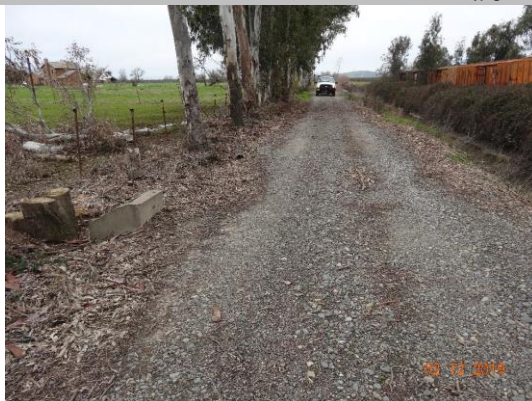
Photo 2 of 3 : UCIP\_FA\_2019\_55484\_79006.jpg

Overview of levee section (high ground) looking west, concrete box located on LS shoulder.

Comment Code						
Inspector Comment						
DS_ID:20120 FS_ID:55484 EP_NO: N/A Repair Type: Non-Urgent Crossing Status: Found UCIP Comments: 02/12/2019 Unit 2 known as the East Levee (East Interceptor Canal) is considered a high ground levee with no defined levee prism, any issue found along this Unit will be considered a maintenance issue, an unauthorized encroachment, or an abandoned encroachment. Record remains Non-Urgent, no permit has been found authorizing pipe. (O. Magana - DWR UCIP)04/10/2017 Crossing appears to be in good condition. (DWR Sutter Yard- AFreitag)10/11/2016 Crossing appears to be in good condition. (DWR Sutter Yard - afreitag)04/19/2016 Crossing appears to be in good condition.05/12/2015 Crossing appears in good condition. No noticeable issues to report.11/17/2014 Same as last inspection.05/12/2014 Same as last inspection.11/04/2013 Same as last inspection.05/15/2013 Same as last inspection.10/16/2012 No permit identified for crossing. FIELD_STRUCT_DESC: 5-inch aluminum drainage pipe through the levee (high ground levee), 1 foot below the crown. Flap gate located on the waterside (WS) with concrete headwall block on the landside (LS). No permit has been identified since crossing was field discovered in 2012. FS Date: 2/12/2019 12:25:00 PM

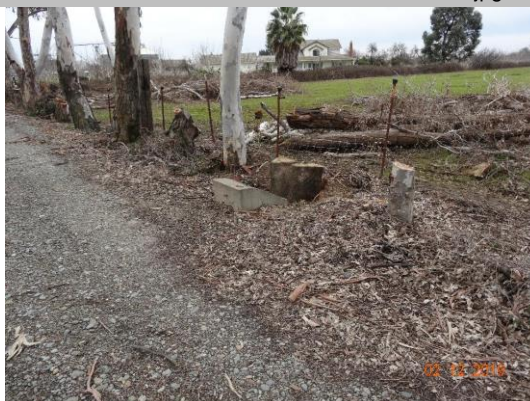
Photo 3 of 3 : UCIP\_FA\_2019\_55484\_79009.jpg

LS view: overview of LS.

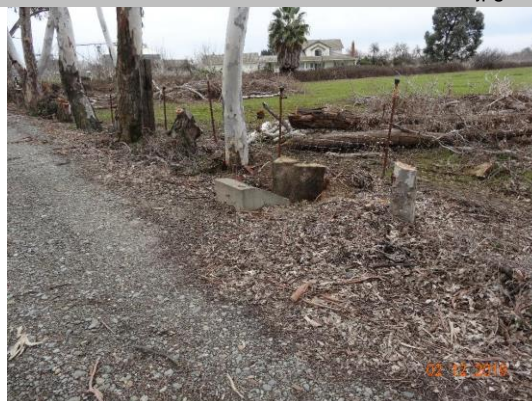
Photo 1 of 3 : UCIP\_FA\_2019\_55485\_79012.jpg

Comment Code						
Inspector Comment						
DS_ID:20121						
FS_ID:55485						
EP_NO: N/A						
Repair Type: Non-Urgent						
Crossing Status: Found						
UCIP Comments: 02/12/2019 Unit 2 known as the East Levee (East Interceptor Canal) is considered a high ground levee with no defined levee prism, any issue found along this Unit will be considered a maintenance issue, an unauthorized encroachment, or an abandoned encroachment. Record remains Non-Urgent no permit has been found authorizing pipe. (O. Magana - DWR UCIP)04/10/2017 Crossing appears to be in good condition. (DWR Sutter Yard - AFreitag)10/11/2016 Crossing appears to be in good condition.(DWR Sutter Yard - afreitag)04/19/2016 Crossing appears to be in good condition.05/12/2015 Crossing appears in good condition. No noticeable issues to report.11/17/2014 Same as last inspection.05/12/2014 Same as last inspection.11/04/2013 Same as last inspection.05/15/2013 Same as last inspection.10/16/2012 No permit identified for crossing.

LS view: no evidence found on LS only concrete headwall associated with 5-inch drain pipe.

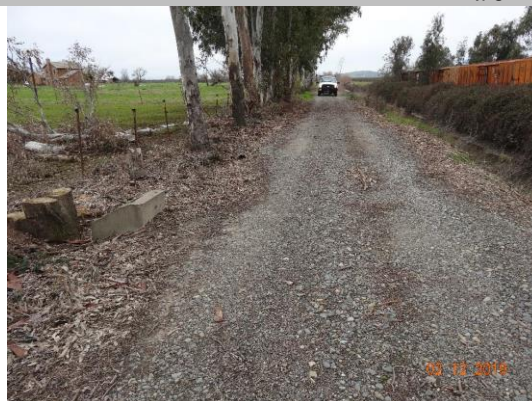
Photo 2 of 3 : UCIP\_FA\_2019\_55485\_79010.jpg

Overview of levee section (high ground) where pipe crosses, concrete headwall visible on LS shoulder.

Comment Code						
Inspector Comment						
DS_ID:20121 FS_ID:55485 EP_NO: N/A Repair Type: Non-Urgent Crossing Status: Found UCIP Comments: 02/12/2019 Unit 2 known as the East Levee (East Interceptor Canal) is considered a high ground levee with no defined levee prism, any issue found along this Unit will be considered a maintenance issue, an unauthorized encroachment, or an abandoned encroachment. Record remains Non-Urgent no permit has been found authorizing pipe. (O. Magana - DWR UCIP)04/10/2017 Crossing appears to be in good condition. (DWR Sutter Yard- AFreitag)10/11/2016 Crossing appears to be in good condition.(DWR Sutter Yard - afreitag)04/19/2016 Crossing appears to be in good condition.05/12/2015 Crossing appears in good condition. No noticeable issues to report.11/17/2014 Same as last inspection.05/12/2014 Same as last inspection.11/04/2013 Same as last inspection.05/15/2013 Same as last inspection.10/16/2012 No permit identified for crossing. FIELD_STRUCT_DESC: 7-inch flexible high-density polyethylene (HDPE) drainage pipe through the levee (high ground levee), 1 foot below the crown. No permit has been identified since crossing was field discovered in 2012. FS Date: 2/12/2019 12:26:00 PM

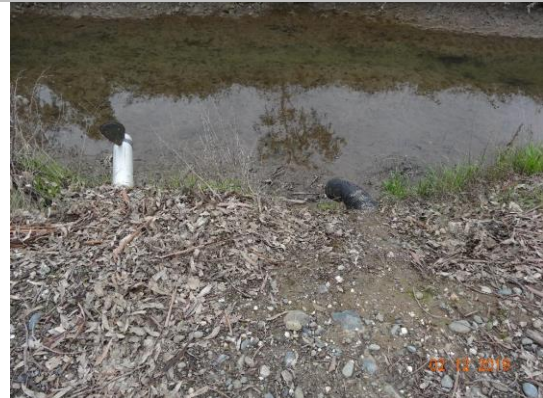
Photo 3 of 3 : UCIP\_FA\_2019\_55485\_79011.jpg

WS view: 5-inch steel and 7-inch HDPE pipes visible on WS.

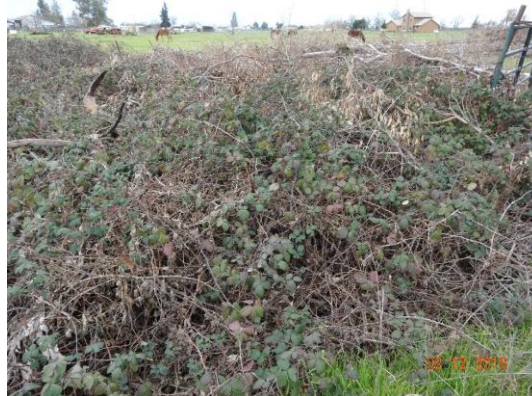
Photo 1 of 3 : UCIP\_FA\_2019\_55486\_79013.jpg

DS\_ID:19437  
FS\_ID:55486  
EP\_NO: 2400  
Repair Type: Non-Urgent  
Crossing Status: Not Found  
UCIP Comments: 02/12/2019 Unit 2 known as the East Levee (East Interceptor Canal) is considered a high ground levee with no defined levee prism, any issue found along this Unit will be considered a maintenance issue, an unauthorized encroachment, or an abandoned encroachment. Record has been updated from No Action Needed to Non-Urgent, status of pipe through high ground levee unknown. No pipe was found. Recommend removing dense vegetation to determine if pipe has been abandoned or recommend conducting geophysical investigation through this section of high ground levee to determine if any signal of metal pipe is detected. (O. Magana - DWR UCIP)04/10/2017 Unable to locate. (DWR Sutter Yard-AFreitag)10/11/2016 Unable to locate.(DWR Sutter Yard -afreitag)04/19/2106 Unable to locate.05/12/2015 Unable to locate.11/17/2014 Unable to locate10//16. 05/12/2014 Same as last inspection.11/04/2013 Same as last inspection.05/15/2013 Same as last inspection. Unable to locate.10/16/2012 Unable to locate.

LS view: dense vegetation covers LS shoulder making it difficult to find pipe.

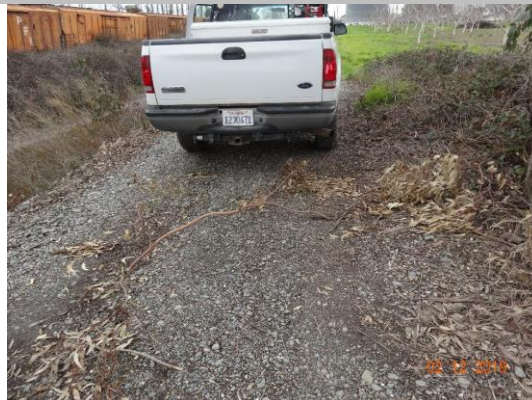
Photo 2 of 3 : UCIP\_FA\_2019\_55486\_79015.jpg

Overview of levee section (high ground) where pipe should cross.

Comment Code						
Inspector Comment						
DS_ID:19437 FS_ID:55486 EP_NO: 2400 Repair Type: Non-Urgent Crossing Status: Not Found UCIP Comments: 02/12/2019 Unit 2 known as the East Levee (East Interceptor Canal) is considered a high ground levee with no defined levee prism, any issue found along this Unit will be considered a maintenance issue, an unauthorized encroachment, or an abandoned encroachment. Record has been updated from No Action Needed to Non-Urgent, status of pipe through high ground levee unknown. No pipe was found. Recommend removing dense vegetation to determine if pipe has been abandoned or recommend conducting geophysical investigation through this section of high ground levee to determine if any signal of metal pipe is detected. (O. Magana - DWR UCIP)04/10/2017 Unable to locate. (DWR Sutter Yard - A Freitag)10/11/2016 Unable to locate.(DWR Sutter Yard - A Freitag)04/19/2106 Unable to locate.05/12/2015 Unable to locate.11/17/2014 Unable to locate10//16. 05/12/2014 Same as last inspection.11/04/2013 Same as last inspection.05/15/2013 Same as last inspection. Unable to locate.10/16/2012 Unable to locate. FIELD_STRUCT_DESC: 24-inch corrugated metal drainage pipe through the levee (high ground levee), at an unknown depth. Flap gate located on the waterside (WS). (24-inch pipe authorized under Permit No. 2400, 1953 - Selma Meyer). FS Date: 2/12/2019 12:26:00 PM

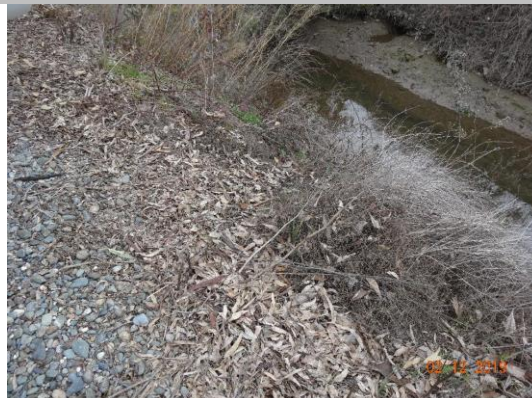
Photo 3 of 3 : UCIP\_FA\_2019\_55486\_79014.jpg

WS view: unable to locate pipe on WS.

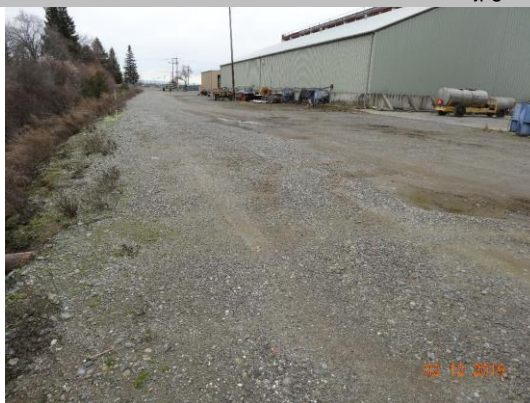
Photo 1 of 3 : UCIP\_FA\_2019\_55487\_79017.jpg

DS\_ID:20123  
FS\_ID:55487  
EP\_NO: N/A  
Repair Type: Non-Urgent  
Crossing Status: Found  
UCIP Comments: 02/12/2019 Unit 2 known as the East Levee (East Interceptor Canal) is considered a high ground levee with no defined levee prism, any issue found along this Unit will be considered a maintenance issue, an unauthorized encroachment, or an abandoned encroachment. Record remains Non-Urgent, no permit has been identified authorizing pipe. (O. Magana - DWR UCIP)04/10/2017 Crossing appears to be in good condition. (DWR Sutter Yard-AFreitag)10/11/2016 Crossing appears to be in good condition.(DWR Sutter Yard - aFreitag)04/19/2016 Crossing appears to be in good condition.05/12/2015 Crossing appears in good condition. No noticeable issues to report.11/17/2014 Same as last inspection.05/12/2014 Same as last inspection.05/22/2013 Erosion under pipe outlet has been repaired. Bank lined with rock to prevent future erosion.05/15/2013 Flexible pipe has been replaced with 6.5 inch steel with flap gate on WS. Erosion under WS outlet.11/04/2013 Same as last inspection.10/16/2012 No permit identified for crossing. FIELD\_STRUCT\_DESC: 7-inch flexible high-density polyethylene (HDPE) drainage pipe through the levee (high ground levee), 1 foot below the crown. Signage for crossing is visible on the landside (LS) shoulder. Outlet visible on the waterside (WS) shoulder. No permit has been identified since crossing was field discovered in 2012.

Overview of levee section (high ground) where pipe crosses.

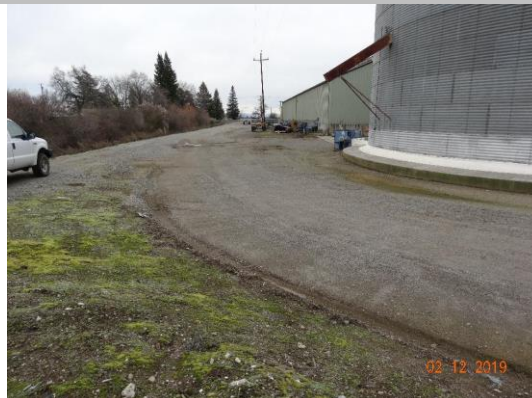
Photo 2 of 3 : UCIP\_FA\_2019\_55487\_79020.jpg

DS\_ID:20123  
FS\_ID:55487  
EP\_NO: N/A  
Repair Type: Non-Urgent  
Crossing Status: Found  
UCIP Comments: 02/12/2019 Unit 2 known as the East Levee (East Interceptor Canal) is considered a high ground levee with no defined levee prism, any issue found along this Unit will be considered a maintenance issue, an unauthorized encroachment, or an abandoned encroachment. Record remains Non-Urgent, no permit has been identified authorizing pipe. (O. Magana - DWR UCIP)04/10/2017 Crossing appears to be in good condition. (DWR Sutter Yard-AFreitag)10/11/2016 Crossing appears to be in good condition.(DWR Sutter Yard - aFreitag)04/19/2016 Crossing appears to be in good condition.05/12/2015 Crossing appears in good condition. No noticeable issues to report.11/17/2014 Same as last inspection.05/12/2014 Same as last inspection.05/22/2013 Erosion under pipe outlet has been repaired. Bank lined with rock to prevent future erosion.05/15/2013 Flexible pipe has been replaced with 6.5 inch steel with flap gate on WS. Erosion under WS outlet.11/04/2013 Same as last inspection.10/16/2012 No permit identified for crossing. FIELD\_STRUCT\_DESC: 7-inch flexible high-density polyethylene (HDPE) drainage pipe through the levee (high ground levee), 1 foot below the crown. Signage for crossing is visible on the landside (LS) shoulder. Outlet visible on the waterside (WS) shoulder. No permit has been identified since crossing was field discovered in 2012.

LS view: overview of LS with minor elevation change between LS ground and levee section (high ground).

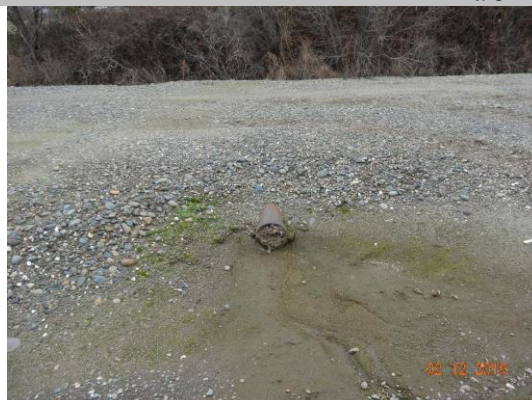
Photo 3 of 3 : UCIP\_FA\_2019\_55487\_79018.jpg

LS view: 6.5-inch steel pipe visible on the LS shoulder.

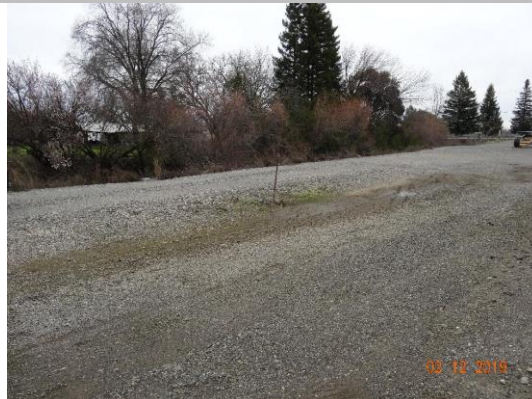
Photo 1 of 3 : UCIP\_FA\_2019\_55488\_79021.jpg

Comment Code						
Inspector Comment						
DS_ID:20124 FS_ID:55488 EP_NO: N/A Repair Type: Non-Urgent Crossing Status: Found UCIP Comments: 02/12/2019 Unit 2 known as the East Levee (East Interceptor Canal) is considered a high ground levee with no defined levee prism, any issue found along this Unit will be considered a maintenance issue, an unauthorized encroachment, or an abandoned encroachment. Record remains Non-Urgent, no permit has been identified authorizing this pipe. (O. Magana - DWR UCIP)04/10/2017 Crossing appears to be in good condition. (DWR Sutter Yard-AFreitag)10/11/2016 Crossing appears to be in good condition.(DWR Sutter Yard - afreitag)04/19/2016 Crossing appears to be in good condition.05/12/2015 Crossing appears in good condition. No noticeable issues to report.11/17/2014 Same as last inspection.05/12/2014 Same as last inspection.11/04/2013 Same as last inspection.05/22/2013 Erosion under pipe outlet has been repaired and bank lined with rock to prevent future erosion.05/15/2013 Flexible pipe has been replaced with 6.5 inch steel with flap gate on WS outlet. Erosion under WS outlet.10/16/2012 No permit identified for this crossing. FIELD_STRUCT_DESC: 7-inch flexible high-density polyethylene (HDPE) drainage pipe through the levee (high ground levee), 1 foot below the crown. Pipe visible on the waterside (WS) shoulder. Intake with grate visible on the landside (LS). No permit has been identified since crossing was field discovered in 2012. FS Date: 2/12/2019 12:27:00 PM

Overview of levee section (high ground) where pipe crosses, photo 1 of 2.

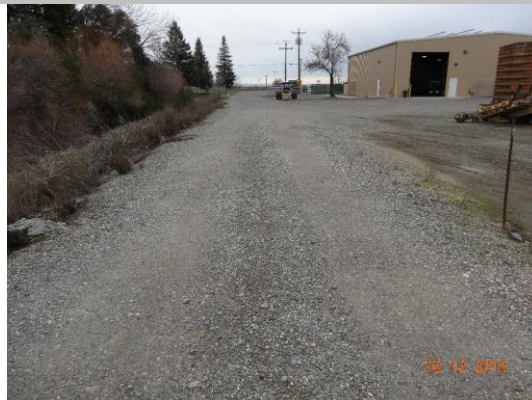
Photo 2 of 3 : UCIP\_FA\_2019\_55488\_79024.jpg

Overview of levee section (high ground) where pipe crosses, photo 2 of 2.

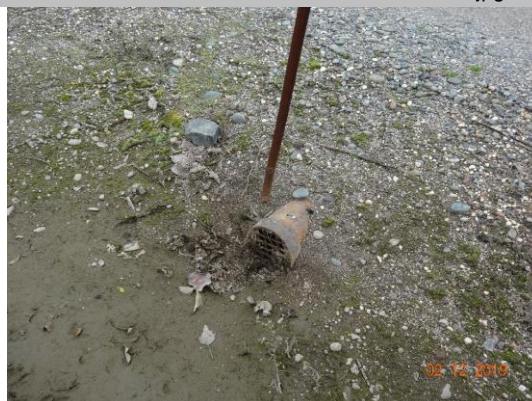
Photo 3 of 3 : UCIP\_FA\_2019\_55488\_79022.jpg

UCIP Comments: 02/12/2019 Unit 2 known as the East Levee (East Interceptor Canal) is considered a high ground levee with no defined levee prism, any issue found along this Unit will be considered a maintenance issue, an unauthorized encroachment, or an abandoned encroachment. Record remains Non-Urgent, no permit has been identified authorizing this pipe. (O. Magana - DWR UCIP)04/10/2017 Crossing appears to be in good condition. (DWR Sutter Yard-AFreitag)10/11/2016 Crossing appears to be in good condition.(DWR Sutter Yard - aFreitag)04/19/2016 Crossing appears to be in good condition.05/12/2015 Crossing appears in good condition. No noticeable issues to report.11/17/2014 Same as last inspection.05/12/2014 Same as last inspection.11/04/2013 Same as last inspection.05/22/2013 Erosion under pipe outlet has been repaired and bank lined with rock to prevent future erosion.05/15/2013 Flexible pipe has been replaced with 6.5 inch steel with flap gate on WS outlet. Erosion under WS outlet.10/16/2012 No permit identified for this crossing.

LS view: pipe inlet with screen to prevent pipe from clogging.

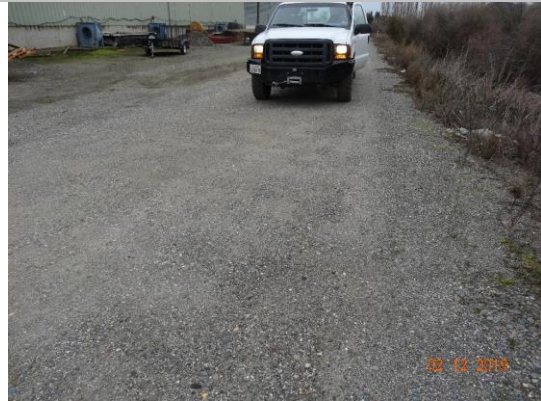
Photo 1 of 3 : UCIP\_FA\_2019\_55489\_79026.jpg

Comment Code						
Inspector Comment						
DS_ID:19428 FS_ID:55489 EP_NO: N/A Repair Type: Non-Urgent Crossing Status: Found UCIP Comments: 02/12/2019 Unit 2 known as the East Levee (East Interceptor Canal) is considered a high ground levee with no defined levee prism, any issue found along this Unit will be considered a maintenance issue, an unauthorized encroachment, or an abandoned encroachment. Record has been updated from No Action Needed to Non-Urgent, no permit has been identified authorizing this pipe. Pipe drains business parking lot. LS inlet is about 250 feet south of levee near building corner. (O. Magana - DWR UCIP)04/10/2017 Crossing appears to be in good condition. (DWR Sutter Yard-AFreitag)10/11/2016 Crossing appears to be in good condition.(DWR Sutter Yard - afreitag)04/19/2016 Crossing appears to be in good condition.05/12/2015 Crossing appears in good condition. No noticeable issues to report.11/17/2014 Same as last inspection.05/12/2014 Same as last inspection.11/04/2013 Same as last inspection.05/15/2013 Same as last inspection. FIELD_STRUCT_DESC: 12-inch polyvinyl chloride (PVC) drainage pipe through the levee (high ground levee), 2 feet below the crown. Pipe drains business parking lot. [Additional Reference(s): DWR Levee Log, Revised 1990]. FS Date: 2/12/2019 2:58:00 PM

Overview of levee section (high ground) where pipe crosses.

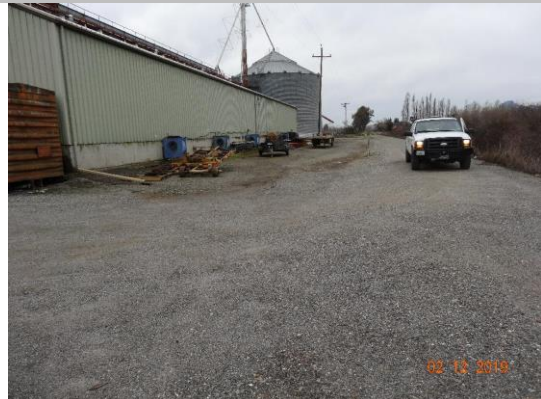
Photo 2 of 3 : UCIP\_FA\_2019\_55489\_79027.jpg

LS view: overview of the LS.

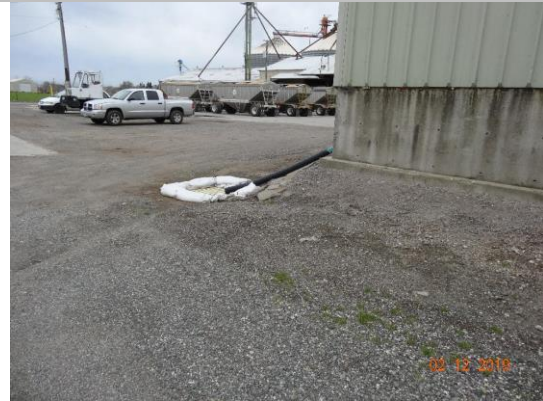
Photo 3 of 3 : UCIP\_FA\_2019\_55489\_79028.jpg

LS view: pipe inlet is about 250 feet south from levee near building corner.

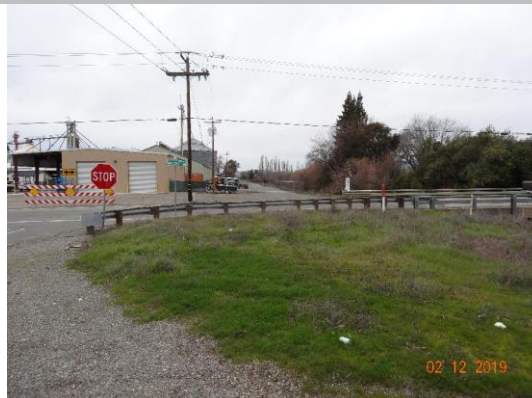
Photo 1 of 3 : UCIP\_FA\_2019\_55490\_79045.jpg

UCIP Comments: 02/12/2019 Unit 2 known as the East Levee (East Interceptor Canal) is considered a high ground levee with no defined levee prism, any issue found along this Unit will be considered a maintenance issue, an unauthorized encroachment, or an abandoned encroachment. Record remains Non-Urgent, no permit has been identified authorizing this pipe. (O. Magana - DWR UCIP)04/10/2017 Crossing appears to be in good condition. (DWR Sutter Yard - AFreitag)10/11/2016 Crossing appears to be in good condition.(DWR Sutter Yard - afreitag)04/19/2016 Crossing appears to be in good condition.05/12/2015 Crossing appears in good condition. No noticeable issues to report.11/17/2014 Same as last inspection.05/12/2014 Same as last inspection.11/04/2013 Same as last inspection.05/15/2013 Same as last inspection.10/16/2012 No permit identified for this crossing.

Overview of levee section (high ground) where com, gas, and drain line cross, photo taken looking east towards crossings.

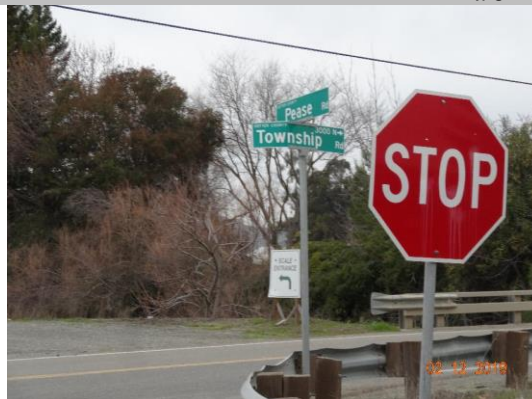
Photo 2 of 3 : UCIP\_FA\_2019\_55490\_79050.jpg

WS view: levee section at Pease Rd and Township Rd.

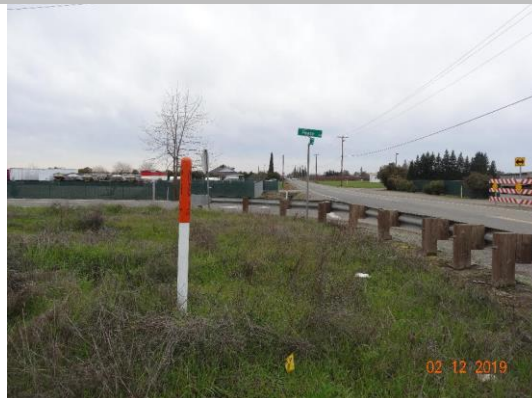
Photo 3 of 3 : UCIP\_FA\_2019\_55490\_79048.jpg

WS view: communication markers continue along the south portion of Township Road.

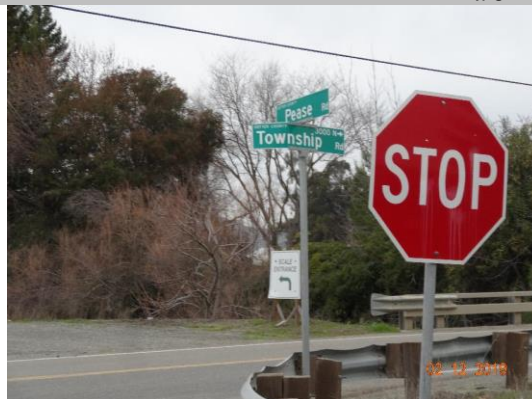
Photo 2 of 3 : UCIP\_FA\_2019\_55491\_79036.jpg

WS view: bridge crossing located on Pease Rd and Township Rd.

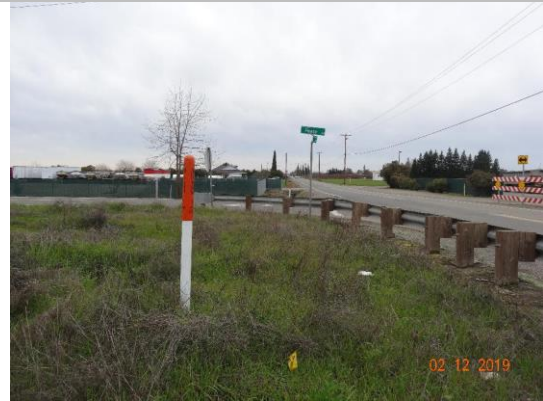
Photo 3 of 3 : UCIP\_FA\_2019\_55491\_79034.jpg

WS view: overview of PG&E line alignment from WS to LS.

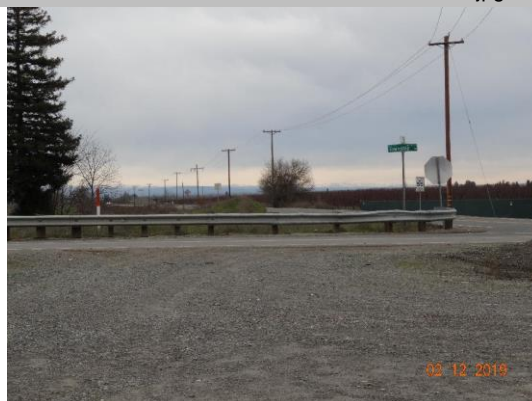
Photo 1 of 3 : UCIP\_FA\_2019\_55492\_79038.jpg

Comment Code						
Inspector Comment						
DS_ID:20127 FS_ID:55492 EP_NO: N/A Repair Type: Non-Urgent Crossing Status: Found UCIP Comments: 02/12/2019 Unit 2 known as the East Levee (East Interceptor Canal) is considered a high ground levee with no defined levee prism, any issue found along this Unit will be considered a maintenance issue, an unauthorized encroachment, or an abandoned encroachment. Record remains Non-Urgent, no permit has been identified authorizing this pipe. (O. Magana - DWR UCIP)04/10/2017 Blackberries around the WS pipe outlet were sprayed and killed. Pipe appears to be in good condition. (DWR Sutter Yard-AFreitag)10/11/2016 WS flap gate is being overgrown by blackberries that could possibly hinder its operation. They should be sprayed and cleared back.(DWR Sutter Yard - afreitag)04/19/2016 Crossing appears to be in good condition.05/12/2015 Crossing appears in good condition. No noticeable issues to report.11/17/2014 Same as last inspection.05/12/2014 Same as last inspection.05/15/2013 Same as last inspection.11/04/2013 Same as last inspection.10/16/2012 No permit identified for this crossing. FIELD_STRUCT_DESC: 18-inch asphalt coated corrugated metal drainage pipe through the levee (high ground levee), 6 feet below the crown. Flap gate is located on the waterside (WS). Pipe is visible on the landside (LS) toe. No permit has been identified since crossing was field discovered in 2012. FS Date: 2/12/2019 3:00:00 PM

Overview of levee section (high ground), looking east towards multiple crossings.

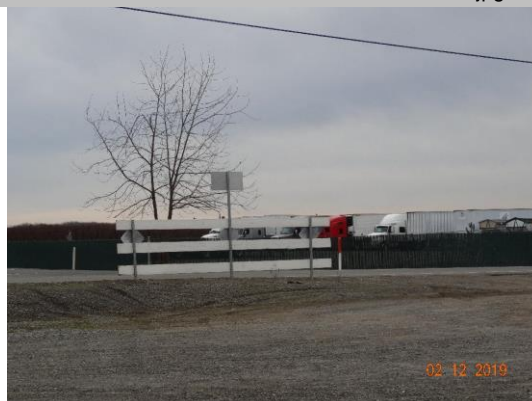
Photo 2 of 3 : UCIP\_FA\_2019\_55492\_79039.jpg

Overview of levee section (high ground), looking south towards multiple crossings.

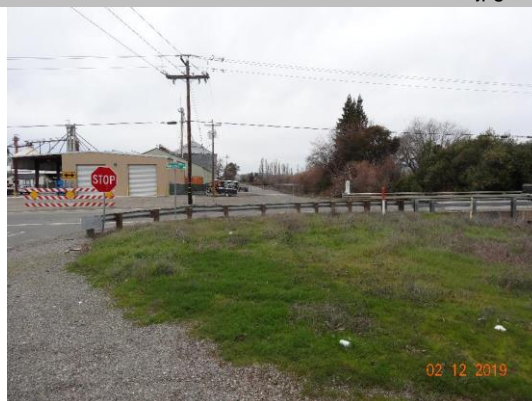
Photo 3 of 3 : UCIP\_FA\_2019\_55492\_79040.jpg

Overview of levee section (high ground), looking west towards com, gas, and drainage line.

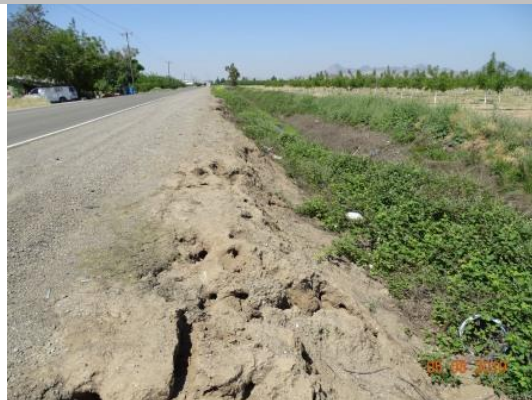
Photo 1 of 1 : FA\_2019\_ST0020\_214\_38\_20190822\_00010.jpg

LM Start	2.72	Rating **	U	Issue No.	38
LM End	2.72	Issue Type +	Ma	Location *	WS
Category	Earthen Levee			GPS Latitude/Longitude	
				Start	End
Item	Animal Control			39.170624 °	39.170624 °
				-121.675992 °	-121.675992 °
DWR ID	DWR_ST0020_02_s_2019_38				
Comment Code					
A3 : No rodents visible, but rodent burrows visible; need to backfill and compact or grout burrows.					
Inspector Comment					
Significant rodent activity is present. The surface runoff is further eroding the waterside shoulder/slope.

View of significant rodent activity on the waterside slope. Spring 2019.
